# Physical analysis of building materials with soil

H Y Jaramillo<sup>1</sup>, J A Gómez<sup>1</sup>, and C A Martínez<sup>1</sup>

<sup>1</sup> Universidad Francisco de Paula Santander, Seccional Ocaña, Colombia

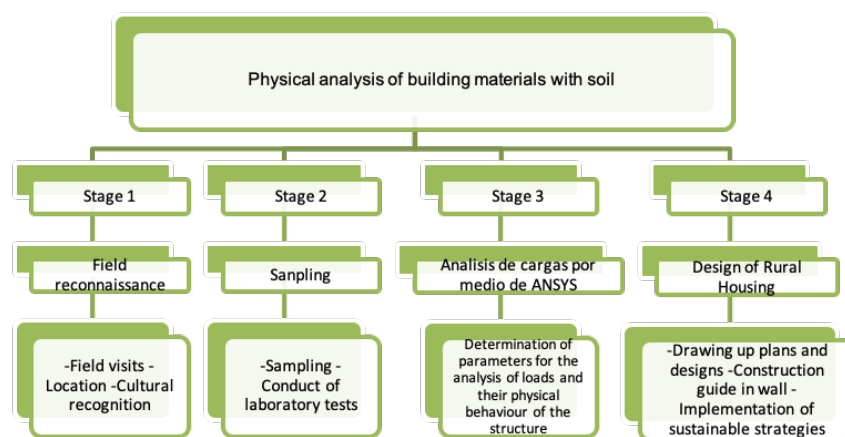
**Figure 1.** General diagram of the methodology adopted in the research.

The research was developed by proposing a set of four stages, which are described in Figure 1. The research methodology is based on the analysis of specific homes in Colombia, Norte de Santander, in the town of Pueblo Nuevo and the Municipality of Playa de Belén. Documentary methods used to review information; this was obtained directly from technical visits made to different homes, in the same way an extensive bibliographic and documentary review has been carried out.

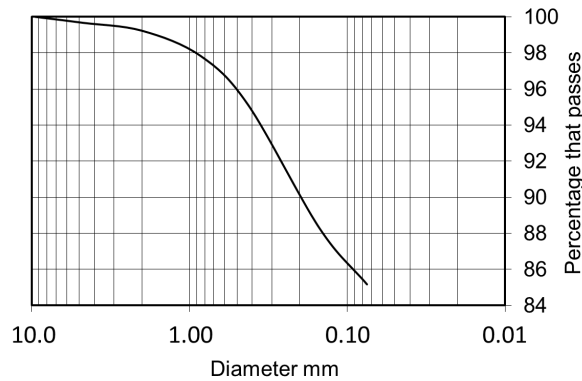
**Figure 2.** Granulometric curve of the material.

characterization of the clays was carried out, initial with a granulometric analysis, as can be seen in Figure 2, following the procedure of [12] with an array of square sieves from  $\frac{3}{4}$  to 200.

As can be seen in the figure, the granulometric curve of the soil indicates a percentage of fines present in the soil in natural condition that exceed 85%, whereas only 0.33% gravel and 14.5% particles were found the size of sands. In addition to this, a scanning electron microscopy analysis was also carried out, with which the size of the soil particle could be established, in this case the sands have sizes between 395  $\mu\text{m}$  and 76.1  $\mu\text{m}$ . These results mainly indicate that the soil in question corresponds to a fine material, with plastic characteristics. Which were determined by calculating the plasticity limit based on the procedure described in [13], and the results are shown in Table 1. With respect to the limits of plasticity and as can be seen in the Table 1, the soil has high values that are characteristic of highly plastic soils. This type of soil is suitable for the construction of wall structures, since the clay content and the plasticity they present give it an adequate consistency.

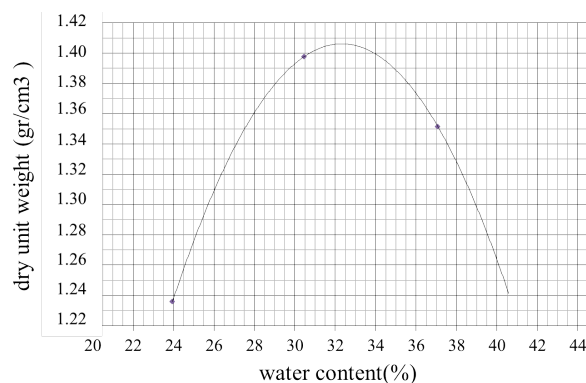
**Figure 3.** Compaction curve.

Regarding the mechanical characteristics of the soil, the proctor test was carried out as indicated in Figure 3, to determine the maximum compaction density of the soil and the optimum humidity, these results are of great relevance since they establish the amount of water which must be added to the soil in order to create a compact paste with the greatest resistance.

According to the graph, the maximum density is  $1.407 \text{ g/cm}^3$  with a humidity percentage of 32.55%, this indicates that in the case of brick walls, they require at least a water percentage of 33% to achieve maximum compaction. of the material. That said, specimens of the material were made with the indicated amount of water, and some tests were carried out to determine the resistance, the results are indicated in the graph of Figure 4. The maximum stress achieved was 3.56 MPa and 3.84 MPa, acceptable values for a brick wall, for which the material under study is suitable for the construction of structures on land, which is now considering the design of a typical single-family home.

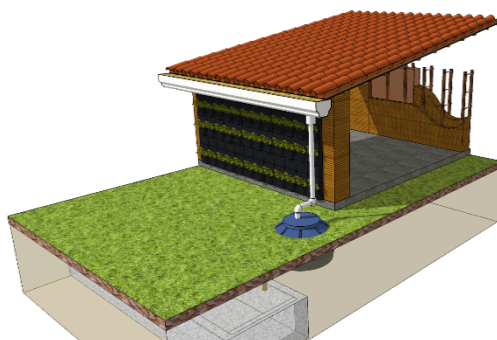
**Figure 5.** General scheme of rural housing.

The wall in Tapia as seen in Figure 5 has a thickness of 0.50 m, manufactured from the compaction of the earth inside a form also called mud, which consists of two wooden boards 1 m high and 2 m long, and two side gates that give the width of the wall, the process consists of introducing the earth brought to the desired condition, in layer thicknesses of 0.10 m later with a "Ram" the process of compaction, then the mud is dismantled and moved horizontally to continue with the process.

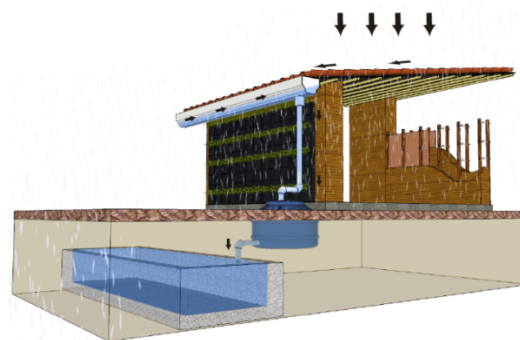
**Figure 6.** Diagram of the water collection and use process.

Figure 6 shows how it is rainwater collection and utilization system was designed taking advantage of the roof area, which acts as a collector, during rainy periods the water that falls on the clay tile roof descends on this given its slope until it reaches a gutter that later leads to a downspout, until reaching a first PVC tank that with the help of filters retain the larger polluting elements such as leaves, then the water is led to a larger tank that stores the water, and from which the water is pumped. Figure 7 shows a general diagram of the process, allowing this to be reused to be used in irrigation systems.

Regarding the green façade, it was thought of a kind of garden with aromatic seedlings, this allows the use of space, in addition to providing a thermal regulation inside the house, decreasing 5 degrees in times of intense heat, and in cold periods it conserves the heat inside. Figure 6 shows a general diagram of the main elements that make up the design of the house.

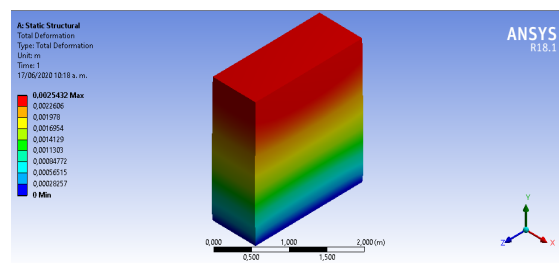
Figure 7. General scheme of rural housing.

Figure 7 and Figure 8 show as part of the analysis developed to the rural housing proposal, a finite model was developed for the analysis of the behavior of the tread wall, in a wall 0.8 m thick and 2.4 m high and 2.0 m high. Width It was modeled considering the load of the wall's own weight and the pressure generated by a clay tile roof that is taken as 1.2 kPa in the upper part of the wall, which was assumed to be embedded in the base for simulation purposes. As can be seen in Figure 8, the greatest deformation occurs in the upper part of the wall where the shift was applied; said deformation corresponds to 2.5 mm.

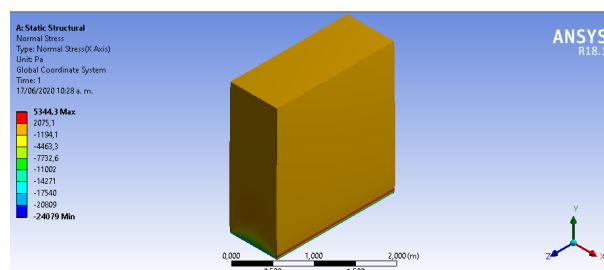
Figure 8. Diagram of the water collection and use process.

Regarding the values of the maximum normal stress and the maximum shear force, as shown in Figure 8, we see that the maximum nominal stress corresponds to 5.3 MPa at the base where the wall rests; likewise, the shear stress has a value of 2.1 MPa, this makes it possible to determine that its structural behavior must be articulated with rigid systems such as gantries, which contribute to better seismic performance and thus improve its resistance to compression and flexion of the wall in wall.
