Análisis y evaluación del riesgo por inestabilidad del terreno en proyectos de urbanización. Un estudio de caso en Tijuana, México

Analysis and assessment of the terrain instability in urbanization projects. A case study in Tijuana, Mexico

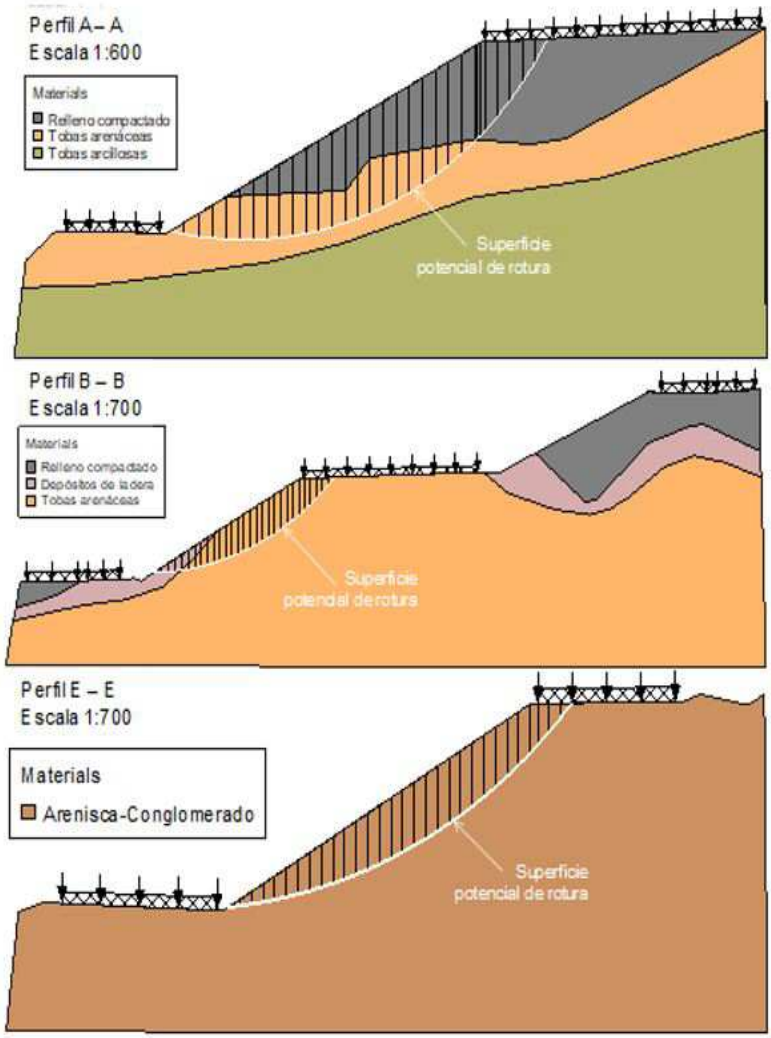
Figure 5. Potential breakage mechanisms.
Source: Authors

Figure 5 shows the failure mechanisms corresponding to the minimum safety factors.

The calculated factors of safety, the depths of the rupture surfaces and the estimated displacements indicate that there is a high probability of occurrence of potentially destructive instability phenomena in the vicinity of profiles A and B.

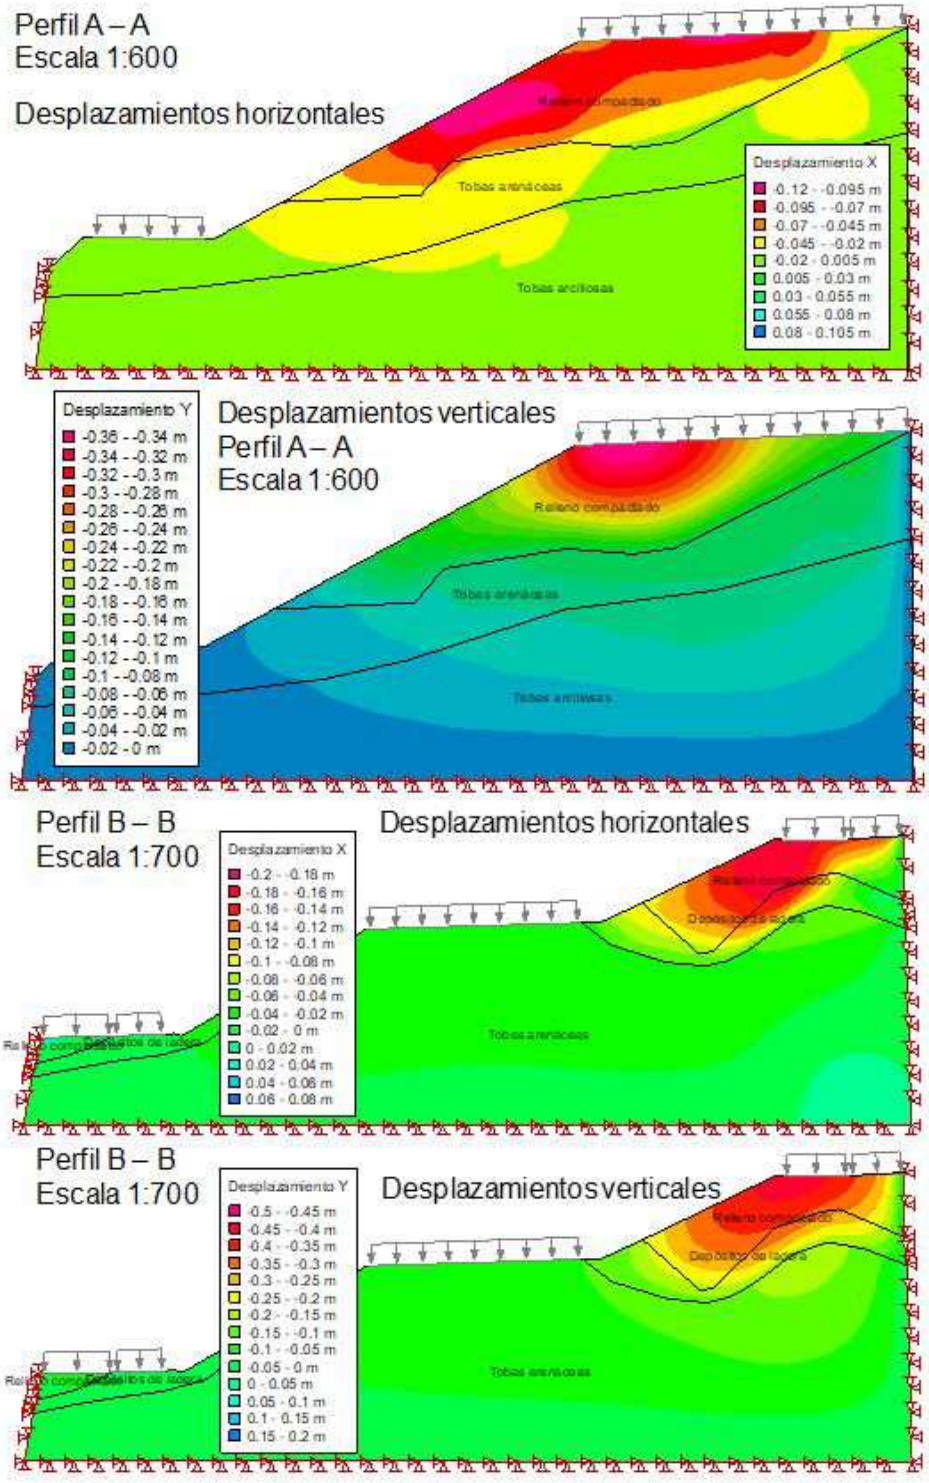
Figure 6. Estimated maximum displacements
Source: Authors

Figure 6 shows the behavior of horizontal and vertical displacements, which are estimated to occur in the terrain around the profiles with the highest probability of instability.

These movements could be unacceptable for the structures and infrastructures to be built.

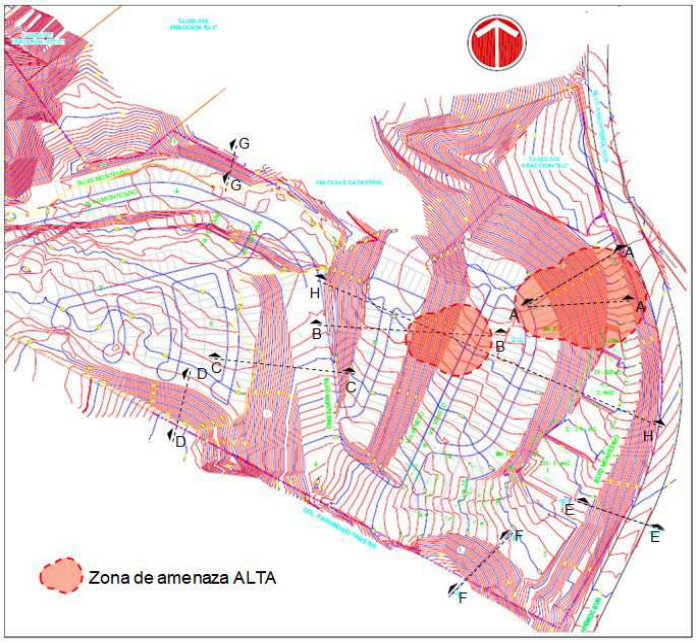
Figure 7 Terrain instability hazard zoning.

Table 6 and Figure 7 present the results of the terrain instability hazard analysis and assessment.

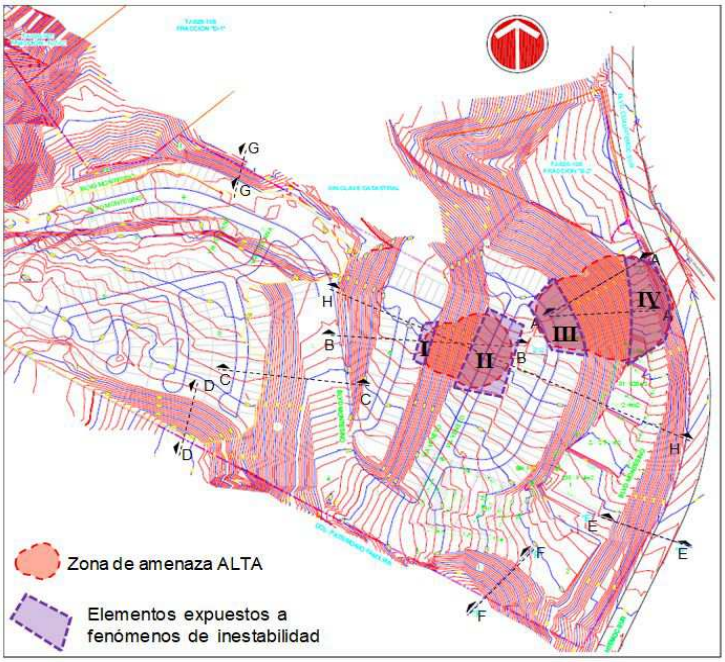
Figure 8 Elements exposed to instability phenomena
Source: Authors

It was performed following the following stages [5]: identification and zoning of exposed elements (Figure 8); characterization; expected damage analysis (Table 7); and vulnerability calculation.

The results indicate high vulnerability to ground instability phenomena.
