Fracture failure analysis of metal materials by visual inspection and destructive testing

Abstract. A methodology is presented to perform fault analysis in metal materials that have failed due to fracture. The proposed method was applied to the study of a fracture presented in the jaw supporting the test pieces in a universal machine used for mechanical tests on materials. The analysis was structured in two stages, initially a visual inspection of the failed element, followed by a series of destructive tests to identify the characteristics of the material and the occurrence of the failure. Visual inspection identified the morphology of the material in the fault zone with gloss and with a characteristic cleavage fracture shape corresponding to a fragile and brittle material. With arc and spark spectrometry the composition of the material was identified, Metallography showed the formation of martensite typical of medium-carbon steels subjected to thermal hardening and scanning electron microscopy identified the precipitation of carbides at the grain boundary, as well as the presence of gaps and other metallic and non-metallic inclusions in the microstructure. The proposed methodolog

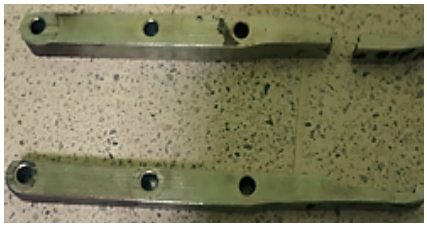
Figure 4 shows the part where the failure occurred. The part was visually inspected and measured. A photographic report was prepared to make a comparison that allowed the classification of the type of failure presented. Toughness is the term used to define a material's ability to plastically deform and absorb energy. Terms such as ductile or brittle are commonly used to define high-toughness (ductile) or low-toughness (brittle) materials. In this context, cleavage fracture is the most brittle fracture mechanism that can originate in crystalline materials. Cleavage fracture can be defined as an extraordinarily rapid propagation of a crack, by the simple separation of the atomic bonds, along a given crystallographic plane [19].

Figure 4. Fractured piece.

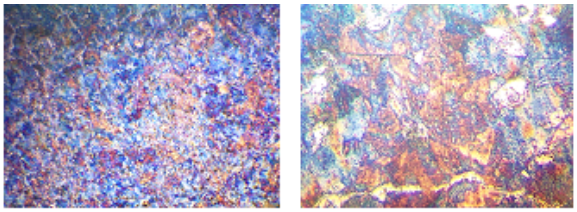
The visual inspection seeks to detail the physical nature of the object inspected. Among these are the size, shape, surface texture, and condition in which it is found, as well as the detail of the defects that allow an assessment of the state in which the material under study is found [20]. Figure 5 shows a fracture of the piece without plastic deformation with a granular appearance on the surface generated by normal stress applied at approximately 90° in the direction of the load. This leads to contemplating the hypothesis of brittle fracture [21].

Figure 5. Fracture in the clamping piece of the jaw; (a) exterior view; (b) interior view.

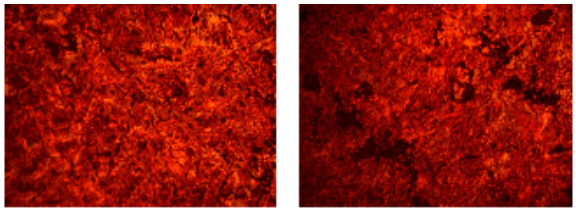
Figure 6 shows the optical micrograph of the sample etched with Nital at different magnifications. Figure 7 shows the sample etched with picral. The metallography reveals the formation of martensite obtained by the rapid cooling of austenite. This is a mixture of lath and plate morphologies with a typical formation of medium-carbon steels [22]. Martensite is a single-phase metastable state. In steel, martensite is a tetragonal crystal structure that occurs when steel is rapidly cooled from the austenite phase [23].

Figure 6. Metallography of the sample etched with Nital at different magnifications. (a) 100X; (b) 400X.

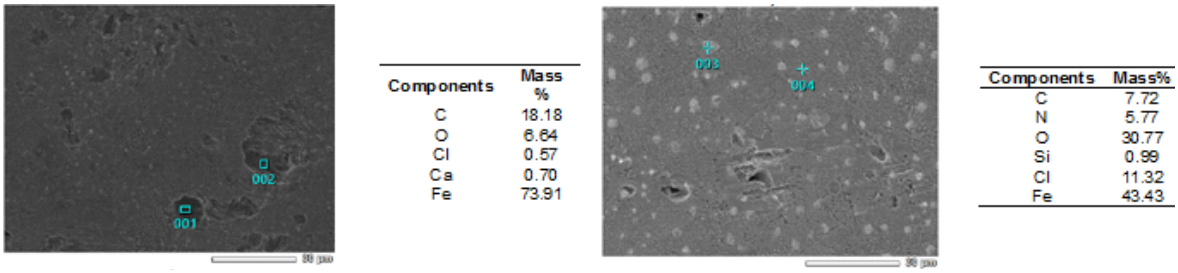
Figure 8 shows the SEM micrograph using EDS. Chemical elements are present in the section analyzed. Also, non-metallic inclusions are present, particularly hard, and non-deformable inclusions.

Components	Mass %
C	18.18
O	6.64
Cl	0.57
Ca	0.70
Fe	73.91

Components	Mass%
C	7.72
N	5.77
O	30.77
Si	0.99
Cl	11.32
Fe	43.43

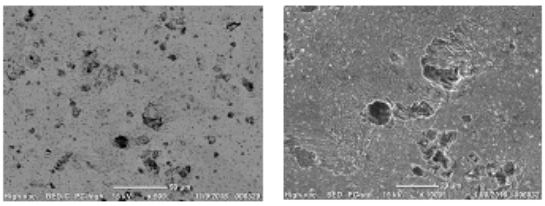
Figure 9 corresponds to the SEM images of the sample that was chemically etched with Nital. Figure 10 shows the sample that was chemically etched with Picral. The micrographs show a matrix with certain porosity that shows irregularities and voids, as well as separation and precipitation of carbides at the grain boundary.

Figure 8. Scanning electron microscopy; (a) Sample etched with Nital; (b) Sample etched with Picral.

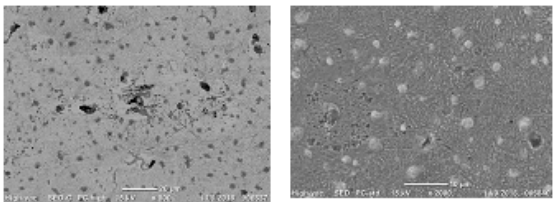
Through the SEM study it is possible to appreciate in detail how the microstructure of the material is, which makes it possible to have reasons of consideration that determine what happened in the failure through the root cause analysis, Therefore, at microscopic size, the fissure and the grain size limits are observed, leaving in evidence incomplete tempering processes that generate structural micro-cracks that cause sudden failure due to fatigue.

Figure 9. Scanning electron microscopy, sample etched with Nital. (a) 500X; (b) 1000X.
